## An Early van from Malta – Nigel Woodford

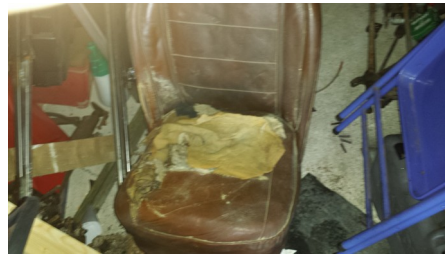
The seats were a little tired

The next decision was whether to go for modern seats or get the original seats refurbished. The more expensive option was to go for original seats. Newton Commercials re-upholstered the seats and made a lovely job of them in a similar brown finish – I also bought new van carpets from them.

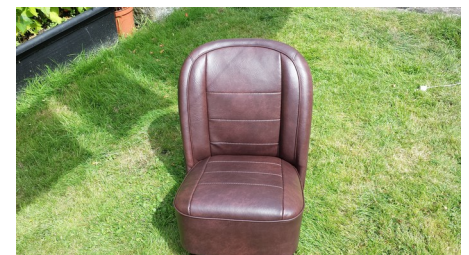
Seat upholstered by Newton

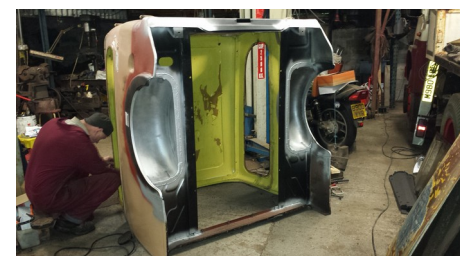
Cargo box being welded

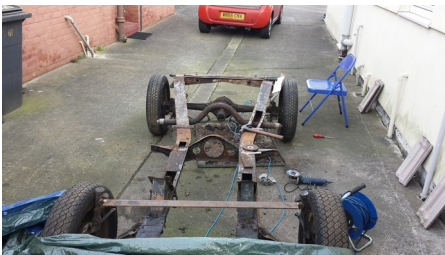
Rigged steering - rusty chassis

Whilst this was going on I had the chassis at home – I cut out the rust with an angle grinder, had the chassis sand blasted and put in primer. I fabricated plates to fit the many damaged areas. I paid a professional welder to repair the chassis whilst strengthening the torsion bar areas and fitting new bump stops. I coated the chassis & the rear axle with 'Rust-Beater' and finally coated both with smooth Hammerite.

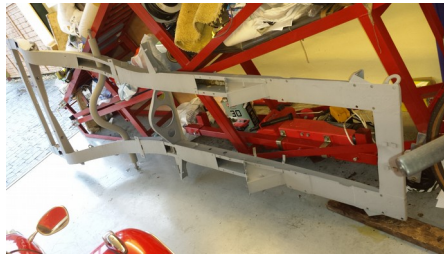
Sand blasted and in primer

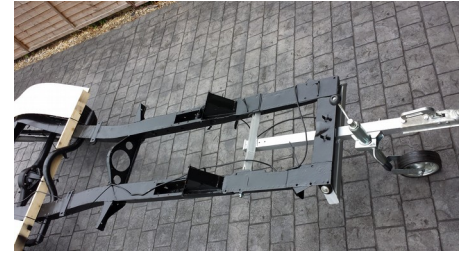
Chassis welded & painted

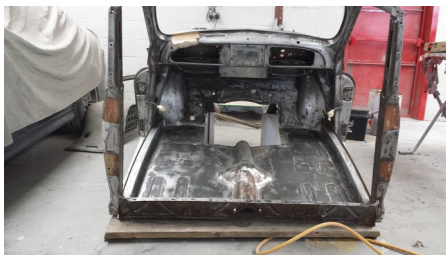
Cab stripped to bare metal

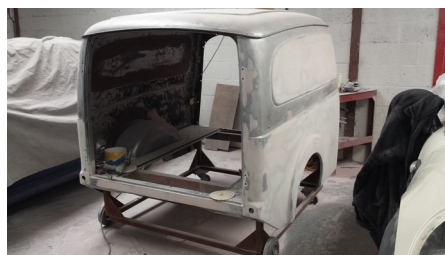
Cargo box with filled panels

The cab and cargo tub were prepared and sprayed separately. I purchased the top half of a scrapped van sides. These were cut and glue/spot welded in place where the side windows used to be. Once in primer I was unable to detect the repair either from the outside or from within.
